# The Evaluation of Aluminum Foil-Interlayered High-Modulus K13CU Pitch Fiber-Siloxane- Modified Resin Composite Panels

15 July 2003

R. J. ZALDIVAR and R. CASTENEDA  
Space Materials Laboratory  
Laboratory Operations

Engineering and Technology Group

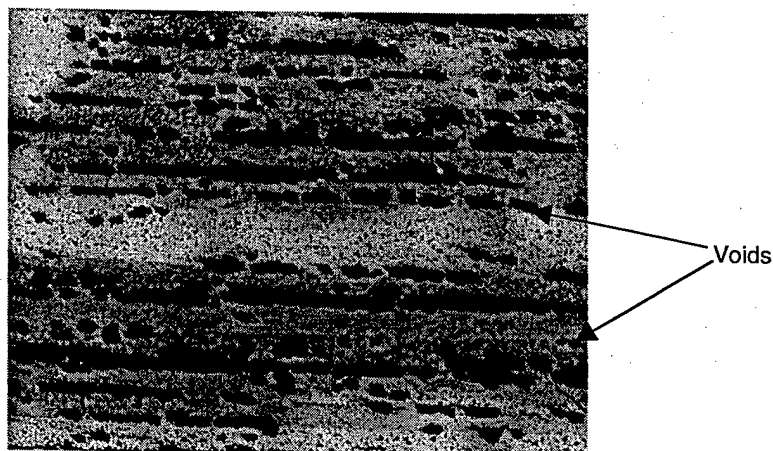
Optical microscopy of the initial lots of composite parts shown in Table 1 indicated that a high degree of interlayer porosity was located throughout the samples. Figures 2 and 3 show cross-sections of a typical K13CU laminate. The black areas in the micrograph represent areas of voids. The lighter areas of gray and white denote the matrix and fiber. As shown, there are substantial void areas oriented along the ply orientation. This is typical of a sample with poor resin flow characteristics and trapped volatiles. However, in this case, it may also be due to the nature of the materials used and the aluminum foil interlayer barrier as shown in Figure 3. As might be expected, the foil may behave as a barrier to the volatiles during cure. The mechanical properties of this composite would be severely degraded, especially in the matrix-dominated directions. A number of composite manufacturing trials were performed by the contractor to eliminate or reduce the porosity and improve consolidation. The set of samples shown in Table 2 were manufactured once the contractor optimized all of the processing issues.

Figure 2. Optical Micrograph showing midplane cross-section of K13CU laminate. Micrograph shows a large degree of interply porosity located between plies.

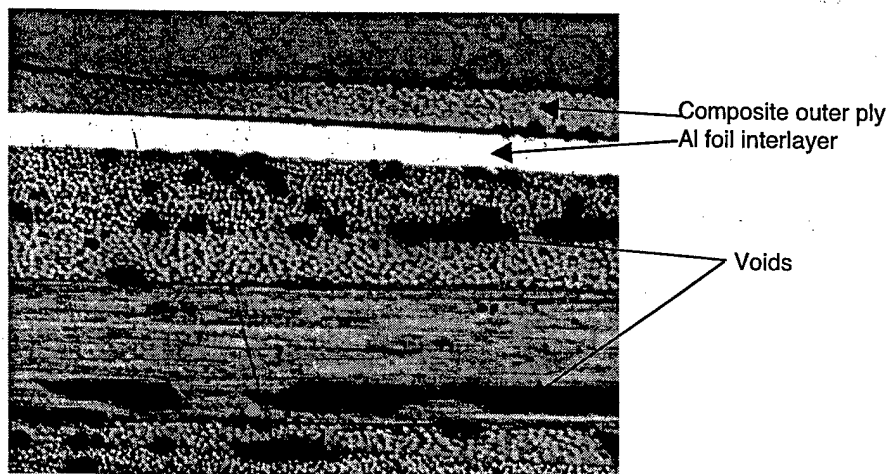
Figure 3. Optical Micrograph showing higher magnification cross-section of K13CU laminate with aluminum-foil interlayer at outer surface.

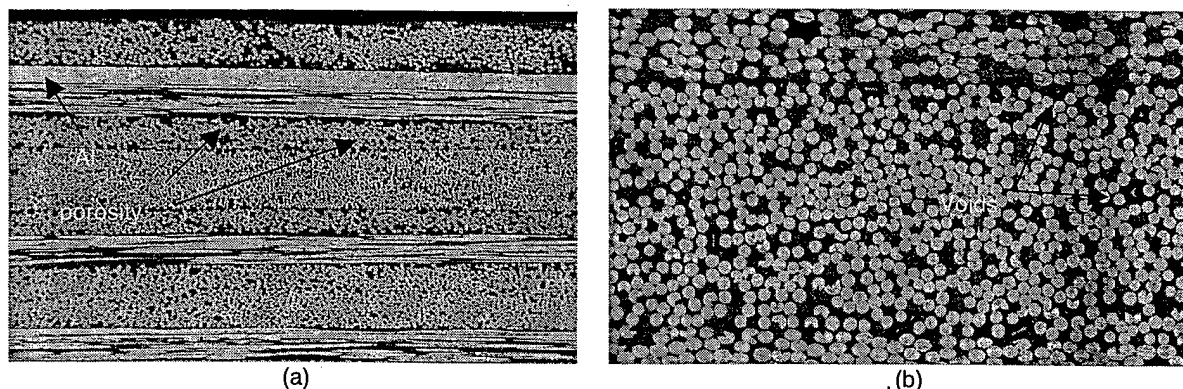
Figures 4-9 show cross-sections of the composites investigated in this study. Figures 4a and b are optical micrographs of sample 1. The white areas are the carbon fibers and the gray area represents the resin matrix material. The variations shown in the fiber cross-sectional area are due to changes in orientation of the plies. As shown, the composite appears well consolidated throughout. However, the small black specks distributed randomly throughout are indicative of closed porosity in the structure. The fiber volume of the outer ply appears to be in the 50% range that is lower than the 60% fiber volume range of the overall composite. However, the purpose of the outerply is more cosmetic than structural.

The aluminum-foil layer can be seen one ply in from the outer surface. Figure 4a shows this layer. The foil appears well bonded to both sides of neighboring laminate plies. Figure 5a shows a higher magnification photo of the aluminum foil within the structure of sample 1. No areas of debonding or excessive fiber-to-metal contact were

Figure 4. Cross-sectional optical micrograph of composite sample 1. The composite appears fairly well consolidated with some porosity observed within plies.

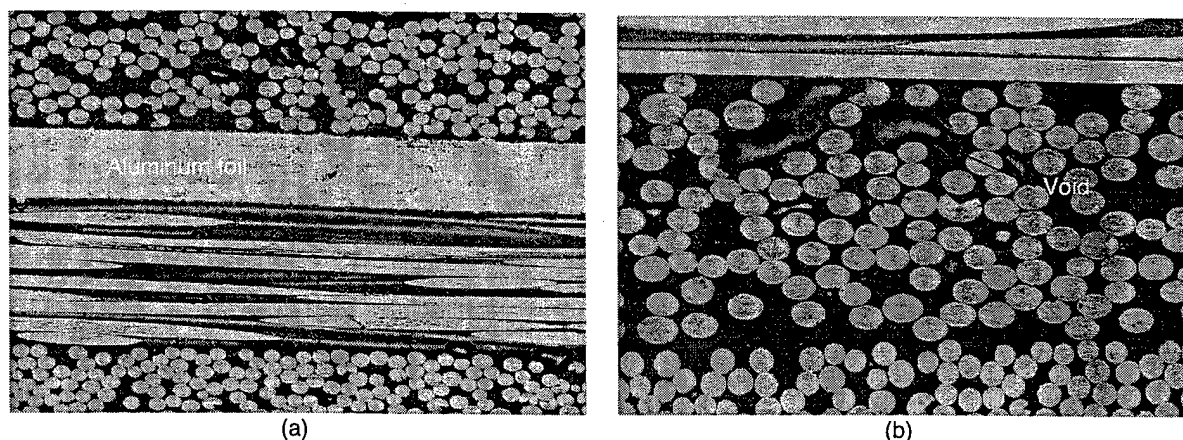
Figure 5. Cross-sectional optical micrograph of composite sample 1. (a) Shows good bonding on aluminum foil in the structure; (b) shows porosity within plies.

observed. Resin-lean areas would account for decreases in interlaminar shear strength; however, the sample appeared fairly resin rich on both sides. Figure 5b shows a higher magnification micrograph of the porosity observed within plies. The porosity appeared fairly well distributed throughout. Image analysis indicated a void volume of less than 2%.

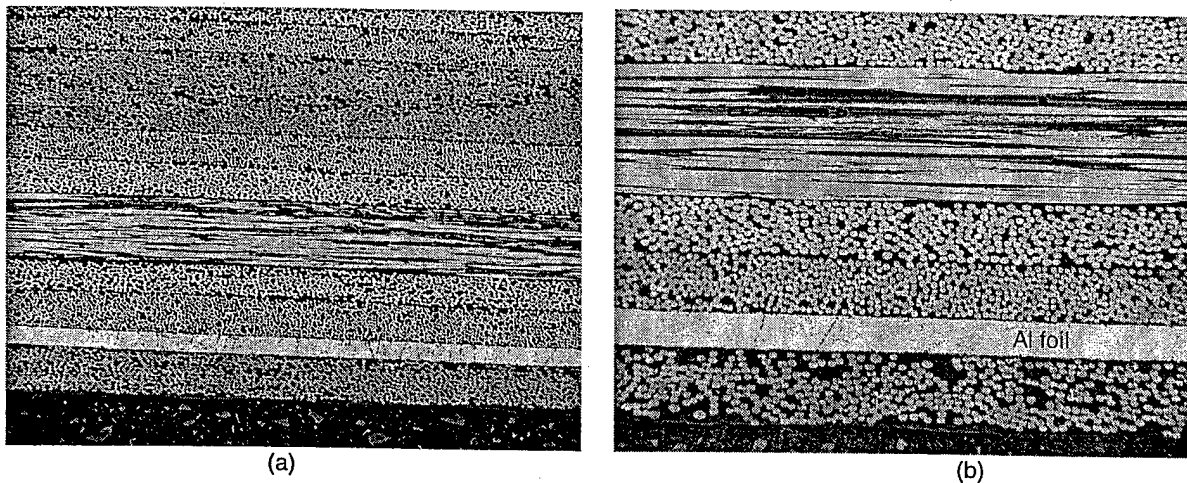
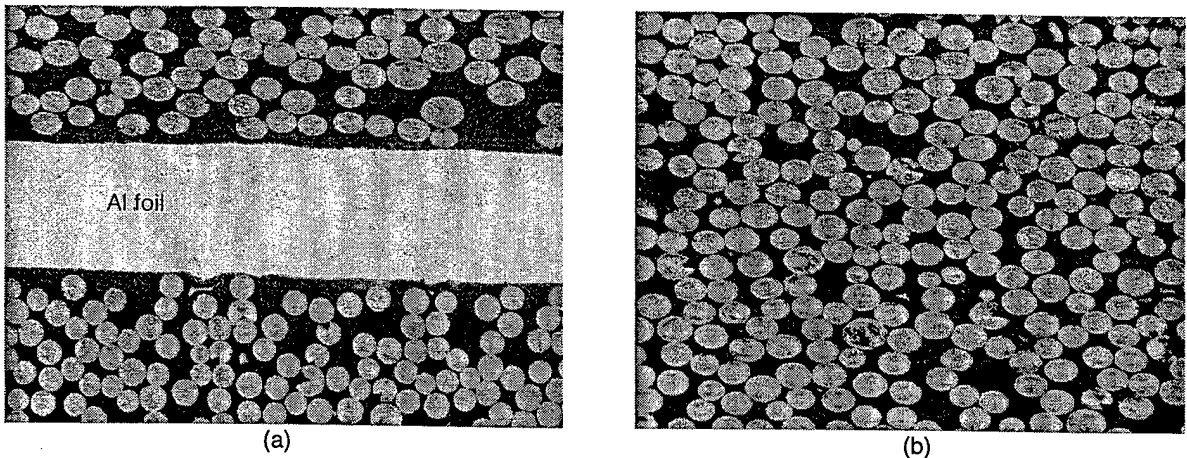
Figures 6 and 7 show cross-sections of sample 2. As shown, there appears to be consolidation and minimal porosity within the plies of this composite also. The aluminum-foil interface appears to be well bonded to the adjacent plies by the matrix material. No indications that would result in decreased mechanical properties were identified.

Figure 6. Cross-sectional optical micrograph of composite sample 2. (a) Shows good consolidation to aluminum foil in the structure; (b) shows low fiber content on outer ply.

Figure 7. Cross-sectional optical micrograph of composite sample 2. (a) shows good bonding on aluminum foil in structure; (b) shows minimal porosity within plies.

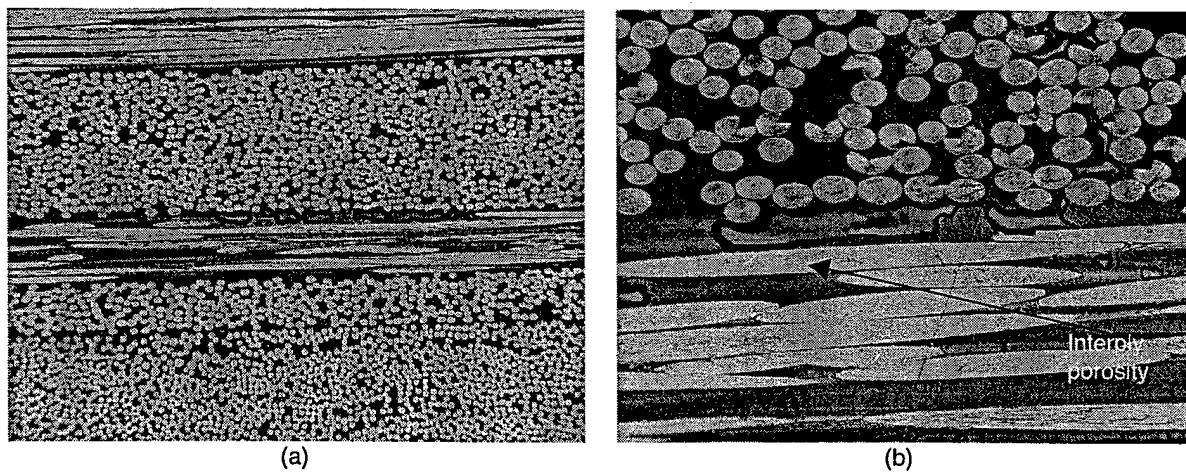
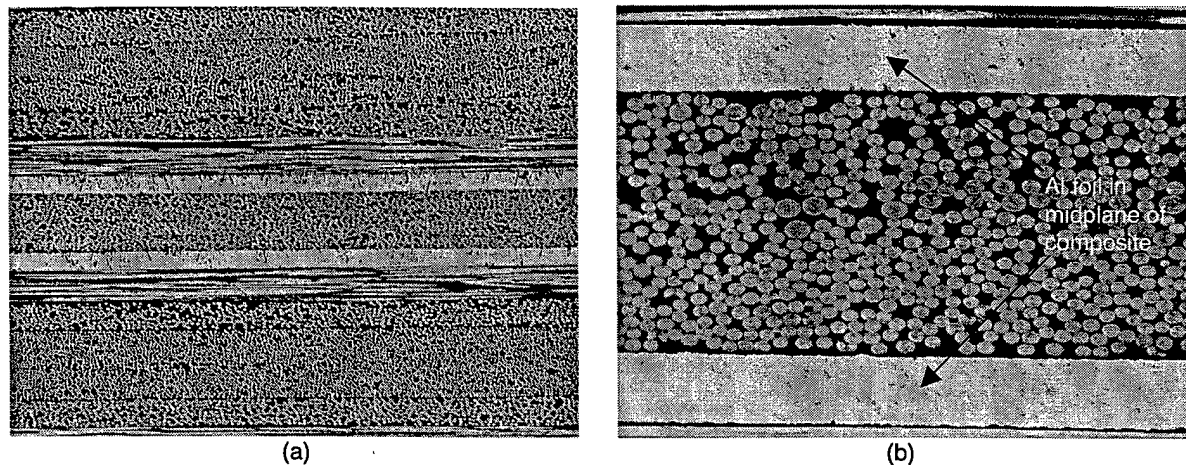
Optical micrographs of microstructural cross-sections of samples 3 and 4 are shown in Figures 8 and 9. Composite sample 3 appeared to have some pronounced porosity between the second and third ply. However, the porosity was limited to a fraction of the entire length of the sample. There were no indications of debonding between the foil layer and the adjacent prepreg. Composite sample 4 was notably different from the other specimens. Two aluminum layers were positioned in the mid-plane of the sample, in addition to the two foil layers closer to the sample surface. Sample 4 exhibited no other differences, which would raise cause for concern. Mechanical tests were then performed on the tag specimens to evaluate the failure mode.

Figure 8. Cross-sectional optical micrograph of composite sample 3. (a) shows good bonding on aluminum foil in the structure; (b) shows porosity within plies.

Figure 9. Micrograph of composite sample 4. (a) shows good bonding on aluminum foil in the structure; (b) shows minimal porosity within plies.

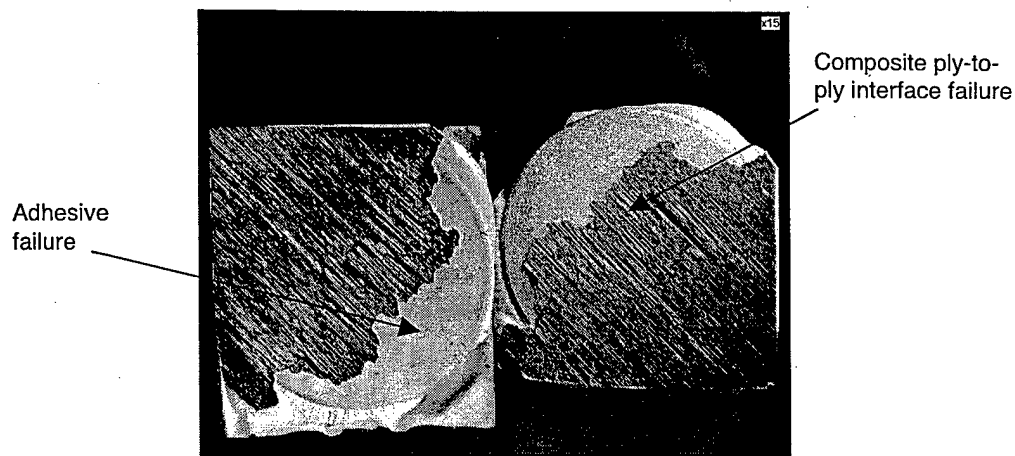
interply performance. The main reason for this testing was not to acquire mechanical strengths, but rather to determine where the failure was occurring. Figure 10 shows the fracture face for a typical flatwise tension specimen. This sample shows a mixed mode. Over 60% of the sample has failed within the composite, exhibiting a ply-to-ply separation. The majority of the failures occur within the first 3 outer plies. In this case, there appears to be some exposed metal from the aluminum plug. This indicates that some of the failure occurred at the interface between the aluminum plug and the bonding epoxy. An ideal sample failure would exhibit no such separation or adhesive failure. The failure load for this sample was somewhat decreased due to this separation. The other 3 specimens exhibited complete ply-to-ply separation.

All of the materials and processing issues appeared to be fine; therefore, the focus of the lower-than-expected strengths was placed on the test laboratory subcontractors specimen preparation procedure. The contractor was notified of our results, and we asked about the failure mode being experienced by the majority of the samples. Only one of our samples out of all of the lots exhibited an aluminum foil to composite separation. The subcontractor analyzed the failed samples and observed that the majority of the failures were actually occurring on the outer surface between the bonding adhesive and the composite face. This failure mode is usually indicative of poor sample preparation. Lower-than-expected strengths would be expected from this type of behavior. In order to improve the bond and get the correct type of failure mode, the composite sample needs to be roughened considerably to ensure a strong mechanical bond with the bonding adhesive. In addition, the type of high-modulus, pitch-based carbon fiber used in this composite is prone to weaker bonding than lower modulus PAN-based fiber typically used. The contractor instructed the testing laboratory in correct sample preparation, and, thus far, all of the composite test specimens appear to be failing within allowable ranges and within the composite.

Figure 10. Fracture surface of sample 1, 2, 3, and 4 all appeared to fail within the composite.

- There appeared to be no issues dealing with the composite material investigated that would cause degradation in flatwise tension strengths. We suggest that the contractor investigate the sample preparation process that the laboratory testing subcontractor is using as well as verify the failure mode of all tested samples.
